Rock Backfill Protection

ASTM G13

Concrete Canvas 13mm Standard Set

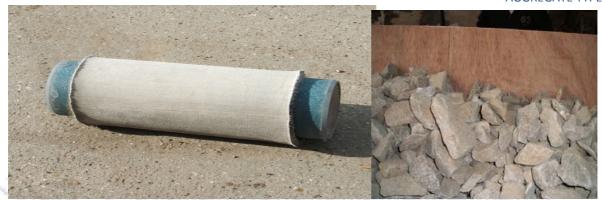
NO DAMAGE TO PIPE COATING

Concrete Canvas CC13 is a Protective concrete cloth on a roll, which is draped over or under pipelines and wetted to hydrate the cement within the system. The standard set product was used and results obtained after 24 hrs with temperatures overnight of 3C 21 KG of 50 mm hard limestone was dropped on to a section of pipe covered in the Concrete Canvas 5 times in a standard ASTM G13 test rig. The surface was analysed and photos taken after each drop.

After 5 drops no damage was apparent on the surface of the concrete cloth. It was hard and durable. No damage was recorded on the epoxy coating.
